**JACOBSON-WESTERGARD  
& ASSOCIATES, INC.**

January 2, 2025

RE: Drainage District No. 25 Branch 48-9 Tile  
Tree Root Issue  
Dickinson County, Iowa  
JWA PROJECT NO: E24143

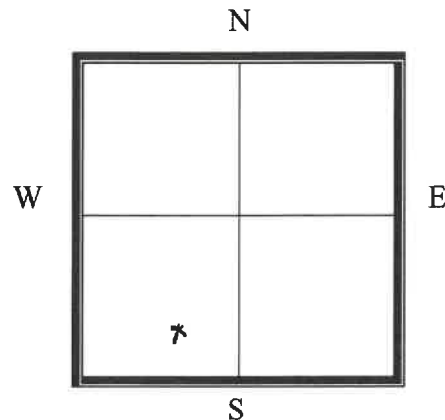
(Grave possible tree roots??)

Nature of problem/work to be done Tile Blocked, televisc to locate problem then repair/clean tile

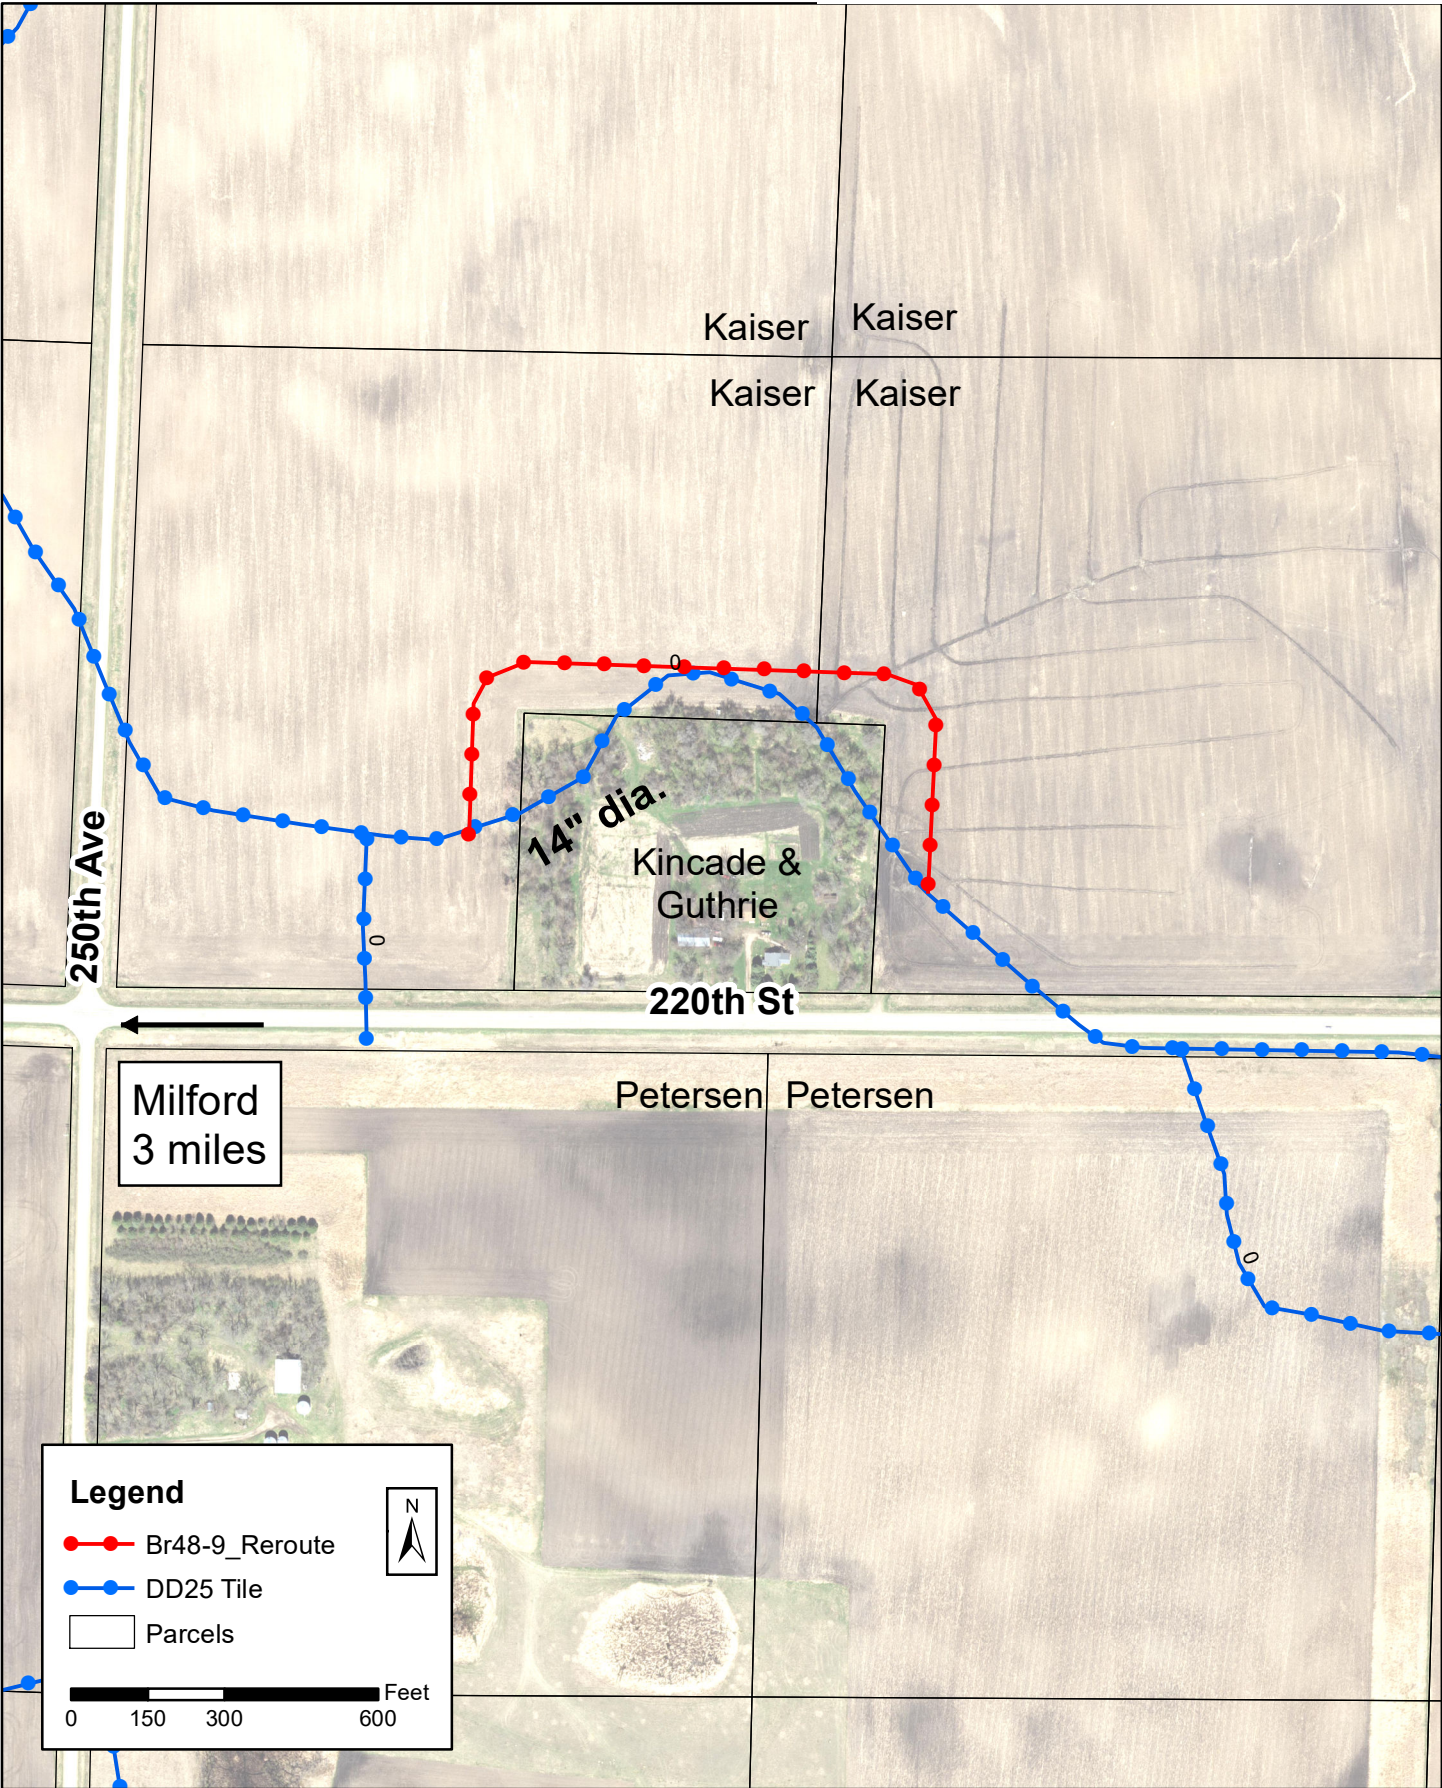
**Drainage District No. 25 Branch 48-9**  
**Tile Re-Route Map**  
Dickinson County, Iowa

After the 2024 harvest, we had Sam Wedeking run a camera into the tile at an intake in the NE corner of the acreage. He found thick tree roots in the tile both directions from the intake. Based on the original profiles of the tile we estimate there to be approximately 3 – 4 feet of cover over the 14" tile through the grove. With trees growing over the tile for 85+ years we can fairly safely assume that throughout the acreage the tile is severely restricted by tree roots. We also have concerns about the condition of the tile, as tree roots growing in the joints eventually crack the tile.

The preferred method of repair in our opinion is to re-route the tile around the acreage. We would recommend keeping the tile 100 feet from the acreage. We have not physically located the tile to know its exact location, but based on the information currently available we estimate that approximately 1,600 feet of pipe would be needed to complete the re-route (additional approximately 400 feet). A repair would mean that 15" diameter tile would be used, at approximately 0.20% grade (we would need to do exploratory excavation to confirm the exact grade would need to be used).

We recommend that the original Branch 48-9 tile through the acreage be abandoned as part of this project. This will ensure that the district is not responsible for future repairs to the tile.

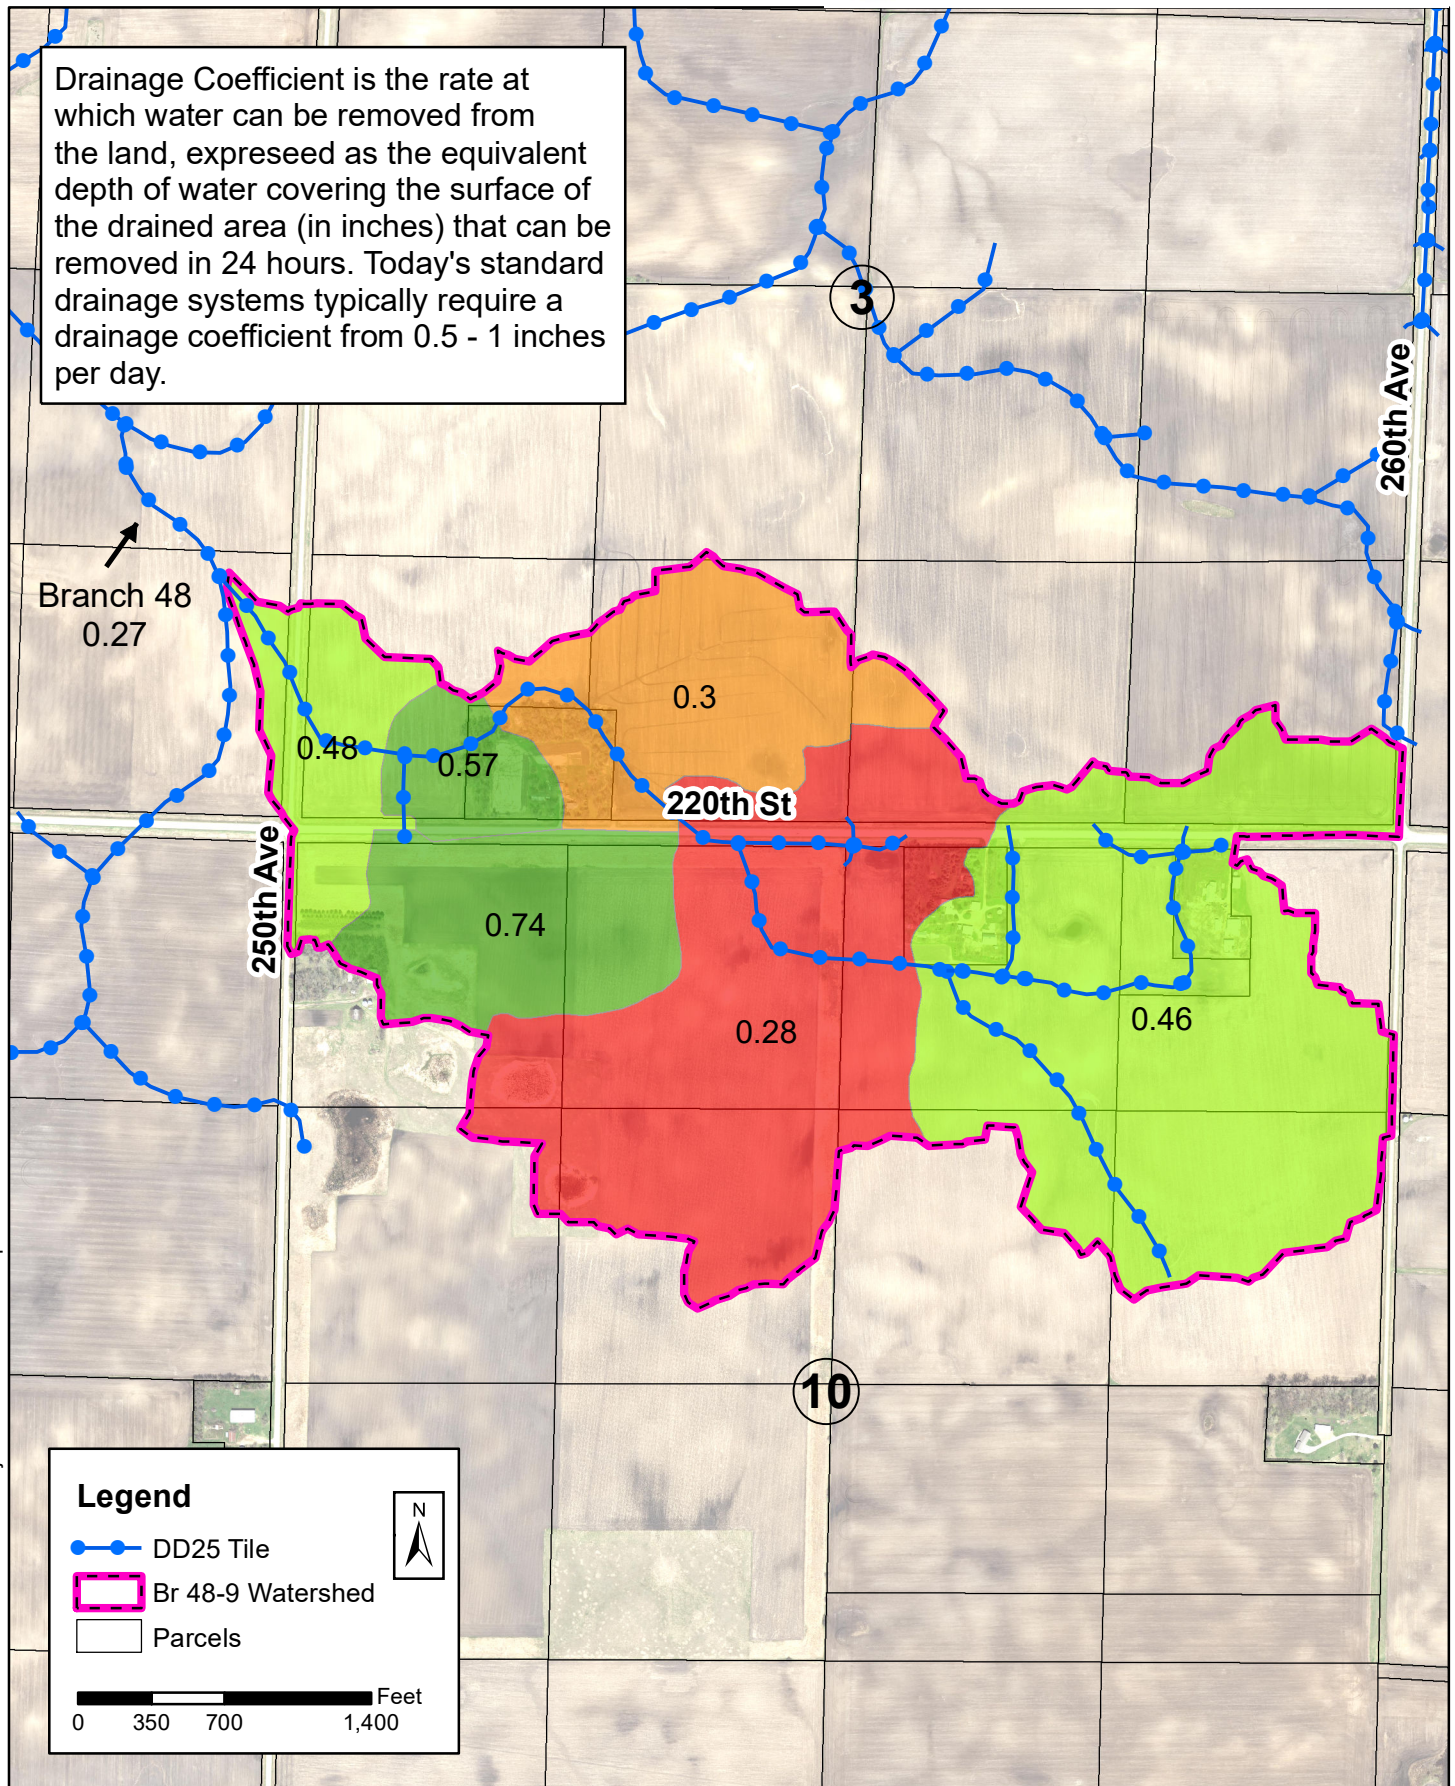
# Drainage District No. 25 Branch 48-9 Drainage Coefficient Map

A large portion of the tile through the acreage is at 0.20% and is undersized at 0.30 inches per day. An 18" diameter tile at 0.20% grade would increase the drainage coefficient to 0.59 inches per day. The lower portions of the Branch 48-9 tile are near or above 0.50 inches per day and as long as they are in reasonable operating condition could be left as they are.

Above the reach with tree root issues, there is nearly a 2,000 ft stretch of tile at 0.12% grade which is at a 0.28 inch per day drainage coefficient. If improvements are desired, we could consider continuing the improvements at least to the south side of County Road A34, if not further.
