**ENGINEER'S REPORT**

**DRAINAGE DISTRICT NO. 76  
TILE REPAIRS / IMPROVEMENTS  
DICKINSON COUNTY, IOWA**

**PROJECT NO: E25021**

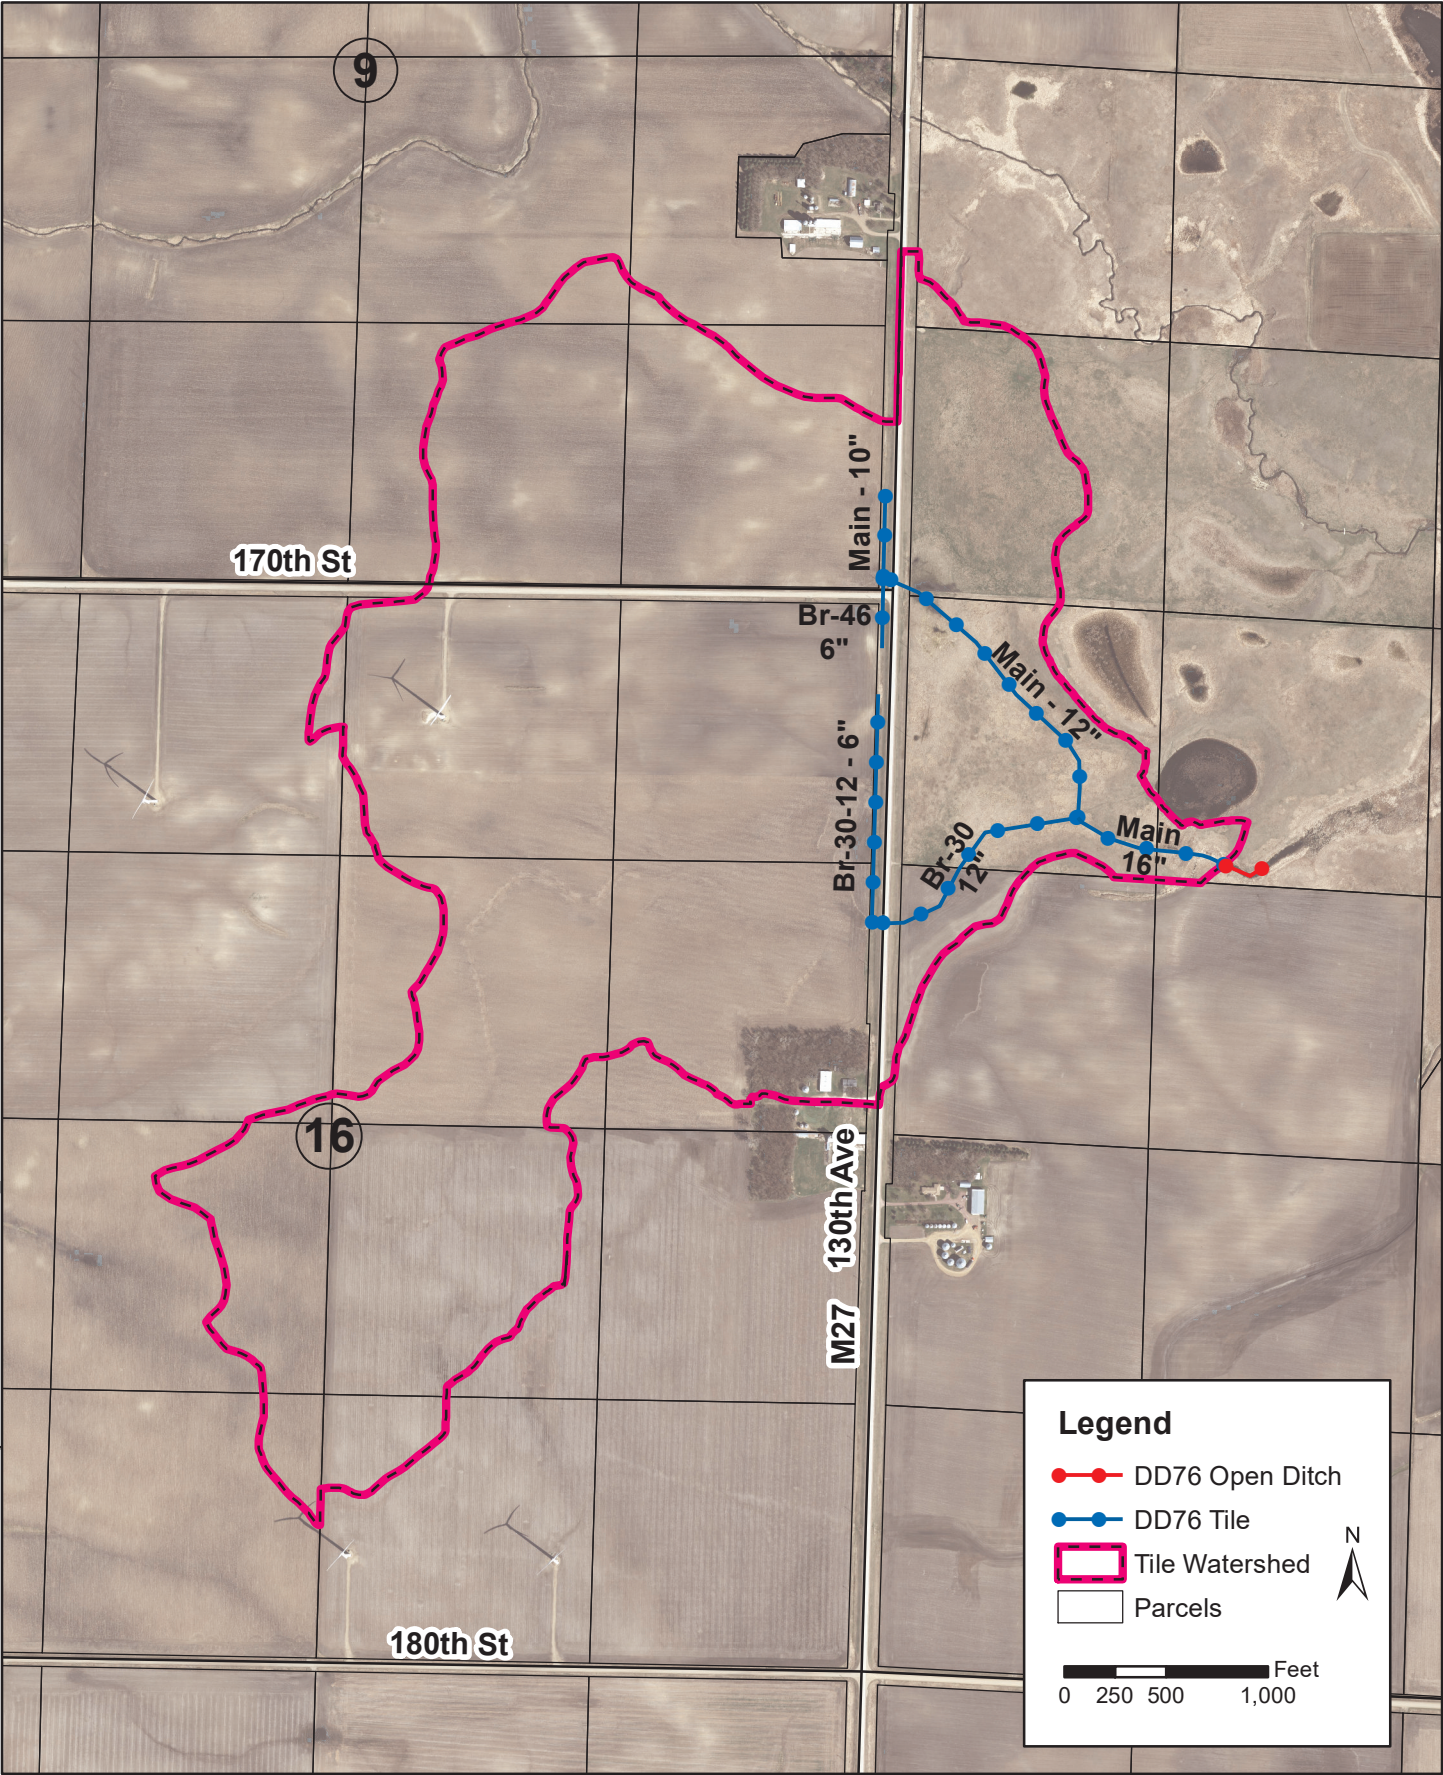
# Drainage District No. 76 Existing Drainage Coefficient Map

Even if operating at full original design capacity the Main Tile would be undersized, with a DC in the lower reaches ranging from 0.26 – 0.32 inches per day. These values are below acceptable levels for efficient drainage. At least double the current design capacity would be required for adequate drainage. As the Main Tile serves as the outlet for all the other district tile branches it is a major restriction for drainage within the district.

Branch 30 and Branch 46 are also significantly undersized, with DC's ranging from 0.21 – 0.28 inches per day.
